Intel® Celeron® Processor in the 478-Pin Package

Specification Update

January 2006

Document Number: 290749-026

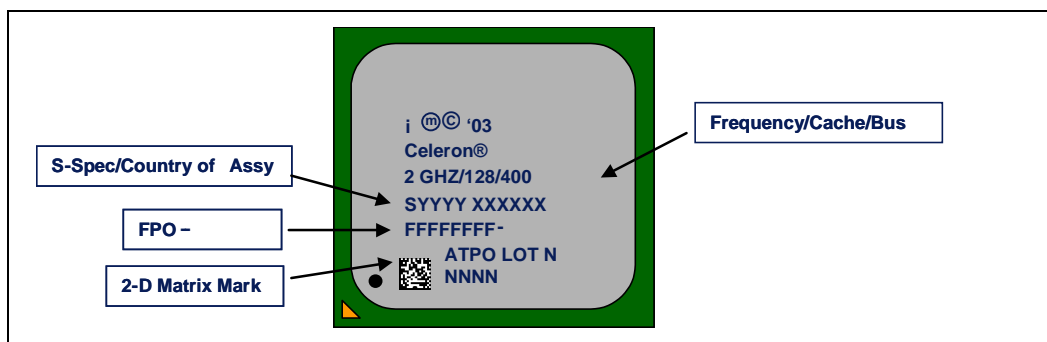
This section contains top marking information for the Intel® Celeron® processor in the 478-pin package.

Figure 1. Example Markings for the Intel® Celeron® Processor on 0.13 Micron Process and/or in the 478-Pin Package
